ST. DOMINIC'S R.C. CHURCH

CARL SCHWARTZ

HILBORNE L. ROOSEVELT
 OPUS 290 (1885)
 LEWIS & HITCHCOCK (1929)
 NEWCOMER ORGAN COMPANY
 (1971-72)
 R.A. DAFFER INC. (1989 AND LATER)

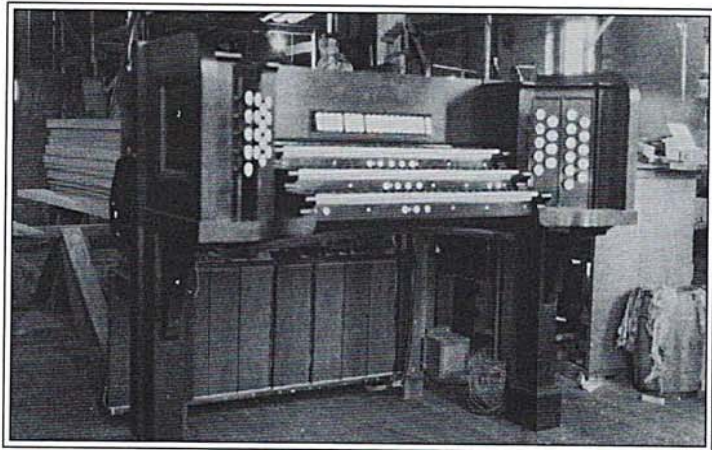
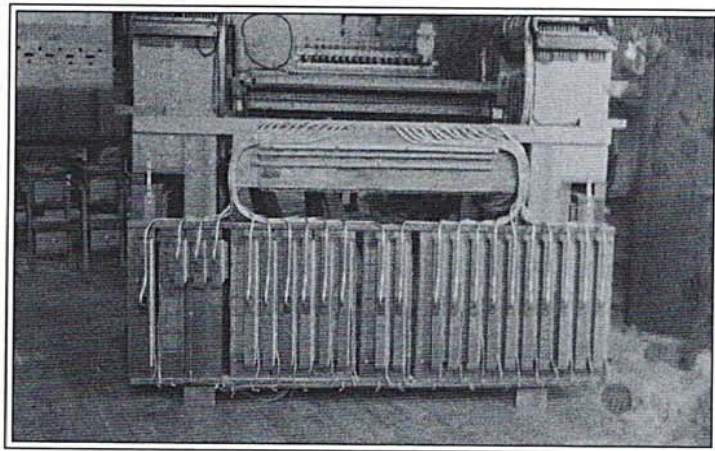
New console insert to replace the tubular/tracker console destroyed by fire/water damage, 1929
